Scott River Beaver Dam Analogue Program 2015 Interim Monitoring Report

Erich Yokel¹, Peter Thamer¹, Chris Adams², Lindsay Magranet³, Wade DeDobbeleer³, Rocco Fiori⁴ and Michael M. Pollock⁵

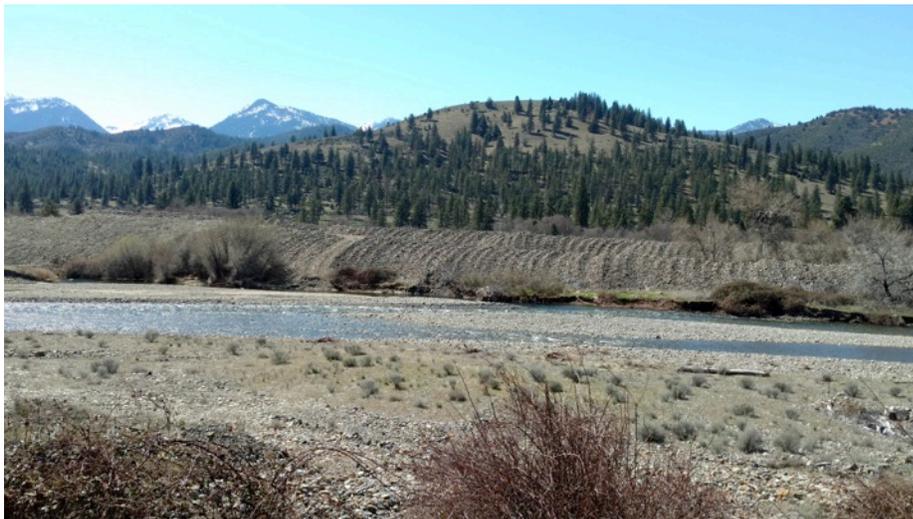
Figure 3. The tailings reach in the upper mainstem of the Scott River, showing the overturned substrate and the lack of riparian vegetation and aquatic habitat simplification. River flow is from left to right. The tailings are the symmetrical mounds of cobble on river left. There is about 6 linear miles of such habitat.

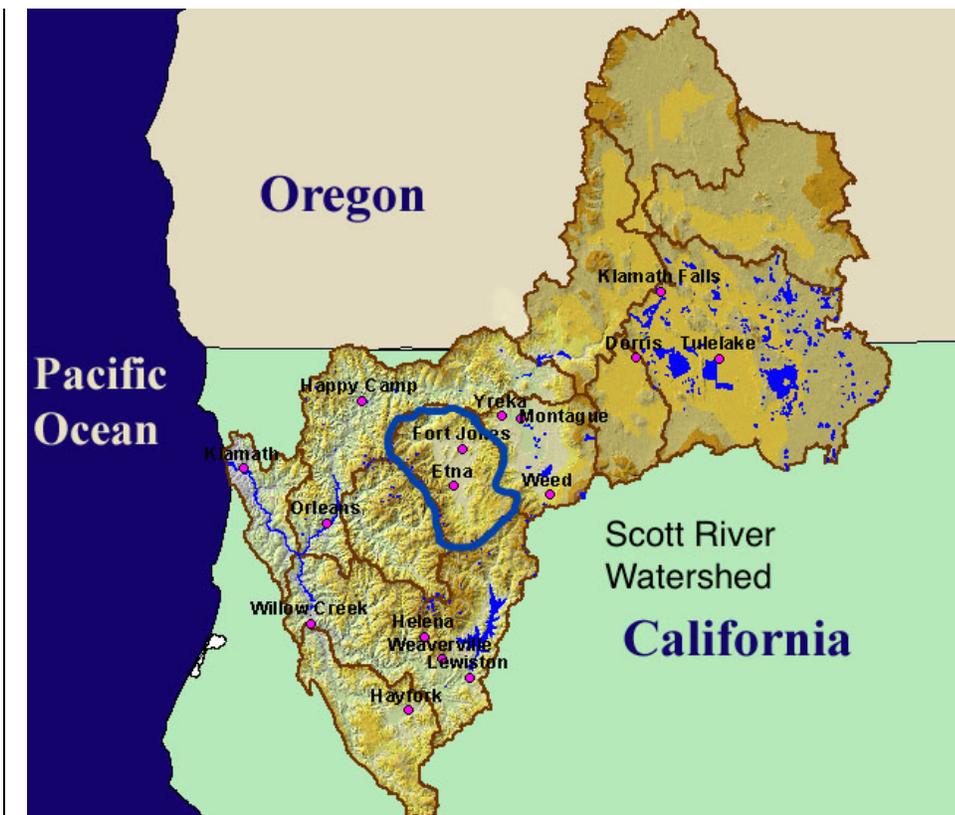
Figure 6. Location of Scott River watershed (circled in blue) within the Klamath River basin. Red lines delineate other major watersheds within the Klamath River basin.

The Scott River is located in the Klamath and Marble Mountains of Western Siskiyou County in Northwest California. The Scott River watershed is approximately 520,000 acres (813 square miles) and is a major tributary to the Klamath River (Figure 6). The East Fork and the South Fork of the Scott River merge at Callahan to form the Scott River. From Callahan the Scott River flows to the northwest about 60 miles where it joins the Klamath River 2 miles above Hamburg. The watershed has a north-south length of about 25 miles and extends in an east-west direction for about 10 miles at its widest part. The area has a human population of about 8000, with “major” population centers in Etna, Fort Jones, Greenview and Callahan. The major industries are agriculture, cattle, timber and recreation. The Pacific Crest Trail passes near the town of Etna

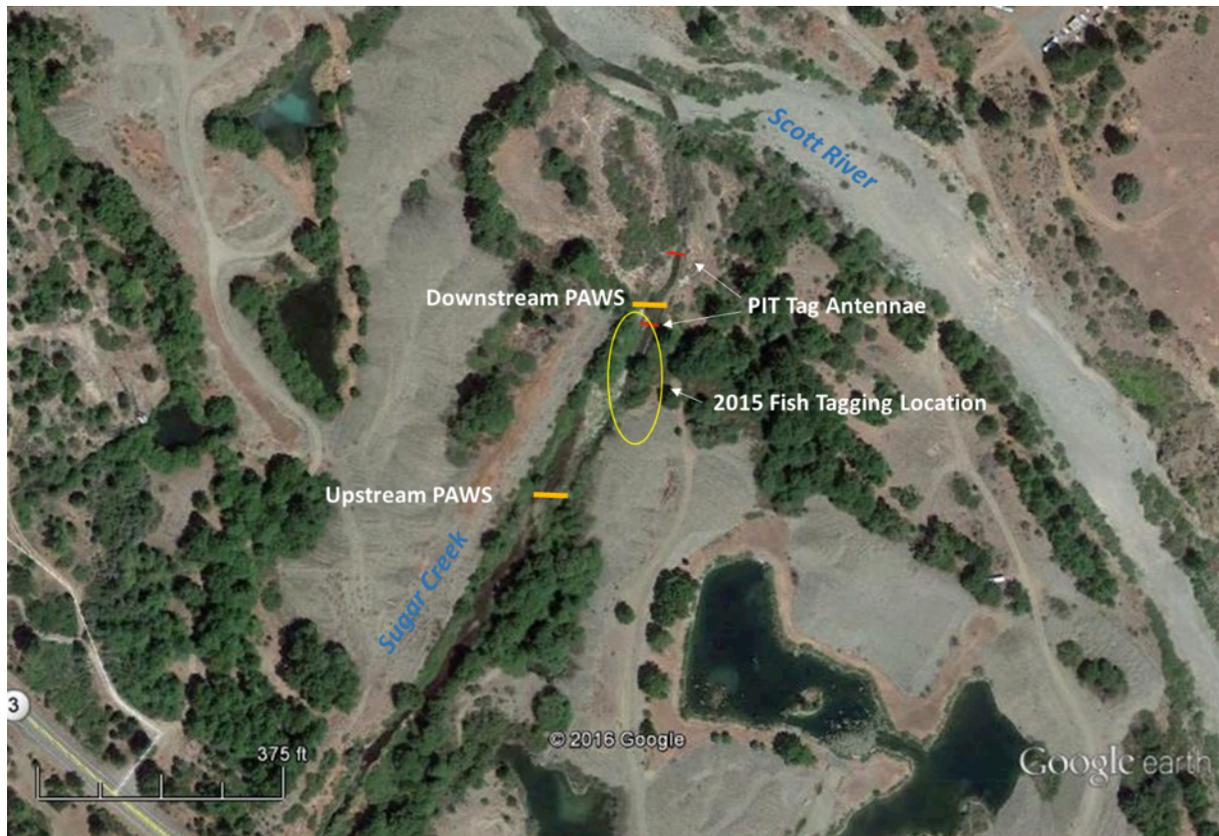
Figure 9. Map of the PIT tag arrays in lower Sugar Creek in relation to BDAs; PAWS = BDAs.

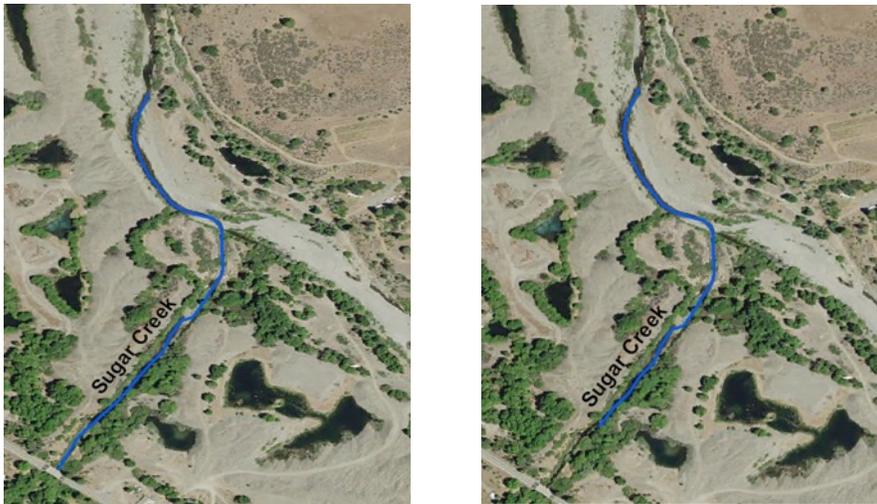
Figure 10. The blue line marks the length of Sugar Creek surveyed on May 28th (left) and June 19th. The shorter survey in June was due to the fact that there was no surface flow just below the Highway 3 bridge. The Scott River was not surveyed. Note that the 2014 ortho imagery shown below does not reflect current the channel configuration.

On May 28th 2015, a snorkel survey was completed from the mouth of Sugar Creek upstream approximately 0.45 miles (as measured by Google Earth) to the State Highway 3 bridge (Figure 10). This length of stream encompasses the BDAs. The purpose of this survey was to assess relative fish abundance by species and age class in lower Sugar Creek. At the time of the survey the CA Dept. of Water Resources stream gage at the Fay Ditch (SGN) recorded a stage from 3.27 to 3.25 feet, which correlates to a discharge of 10.5 to 10.0 cubic feet per second. There was complete surface water connectivity through this reach of stream and the water clarity/visibility was good to excellent. Water temperatures during the survey were 13 -14 °C.

On June 19th, 2015, a second snorkel survey was completed from the mouth of Sugar Creek upstream approximately 0.37 miles (as measured by Google Earth) through the BDAs project site (Figure 10). The purpose of this survey was to assess relative fish abundance by species and age class through the length of Sugar Creek influenced by the structures. At the time of the survey the CA Dept. of Water Resources stream gage at the Fay Ditch (SGN) recorded a stage of

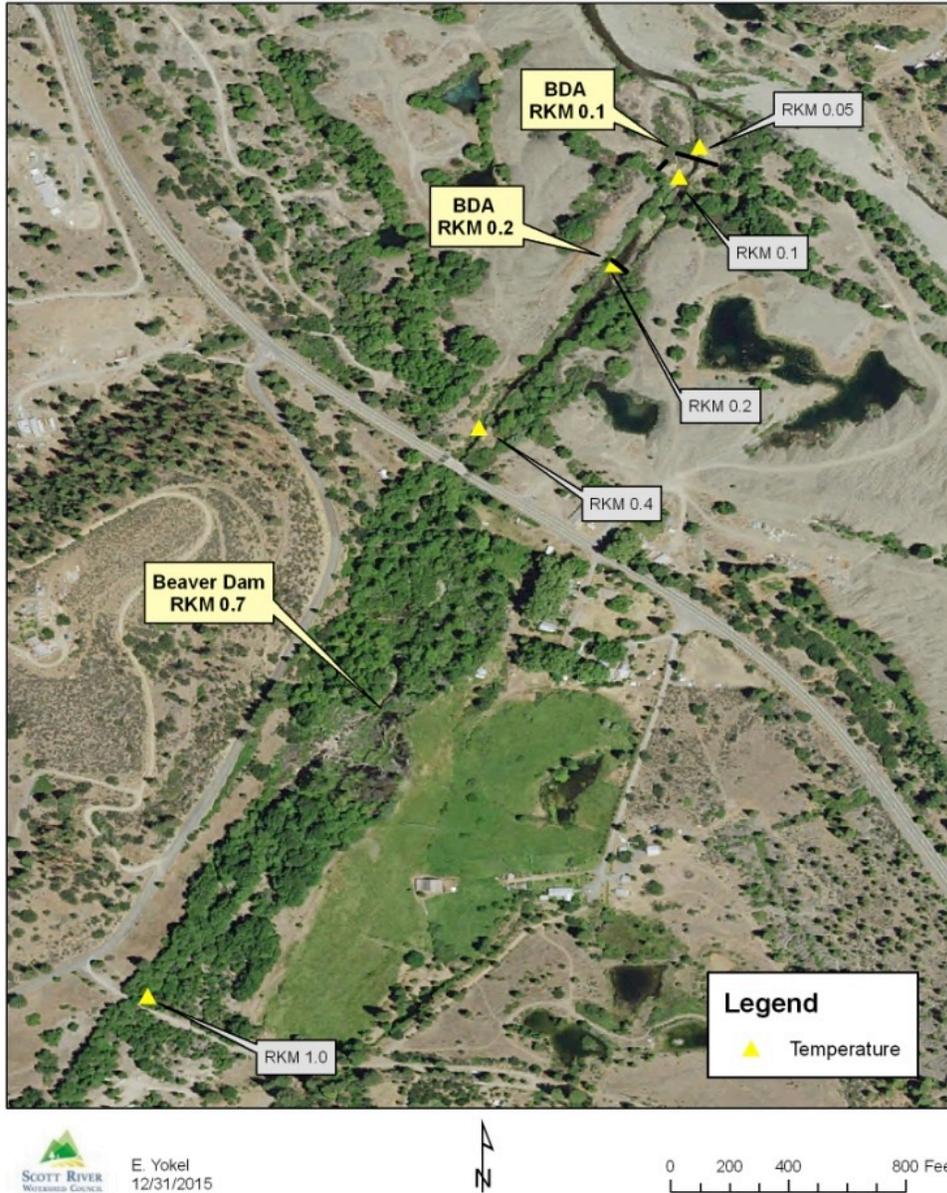
Figure 12. Location of surface water temperature monitoring stations in lower Sugar Creek, used in this study, in relation to the beaver dam analogues which were installed (thin black lines). Rkm = river kilometer, which refers to the distance upstream from the mouth of a river or creek.

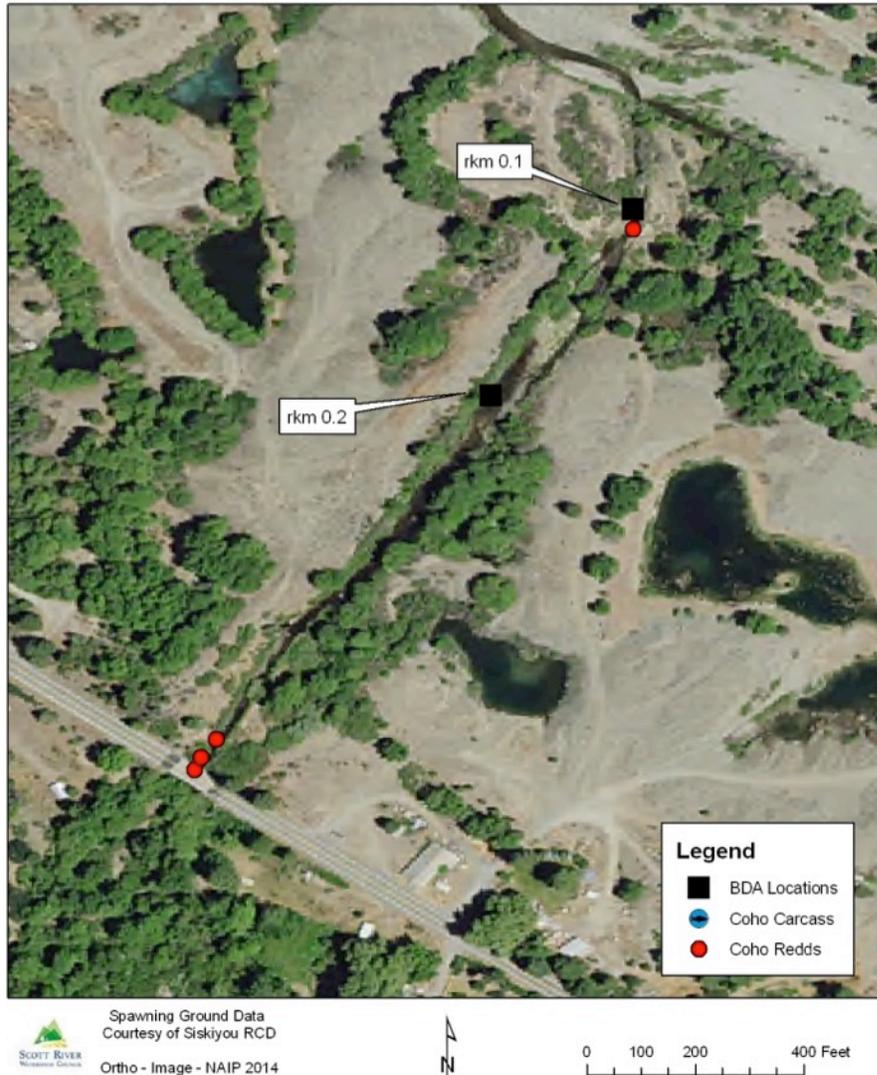
Figure 19. Coho spawning and carcasses observed in Sugar Creek in the fall and winter of 2015-2016. Figure 7. BDA = beaver dam analogue. Rkm = river kilometer, which refers to the distance upstream from the mouth of a river or creek. There is no fish blockage at the highway, but the gradient rapidly steepens above the highway and is not ideal for spawning.

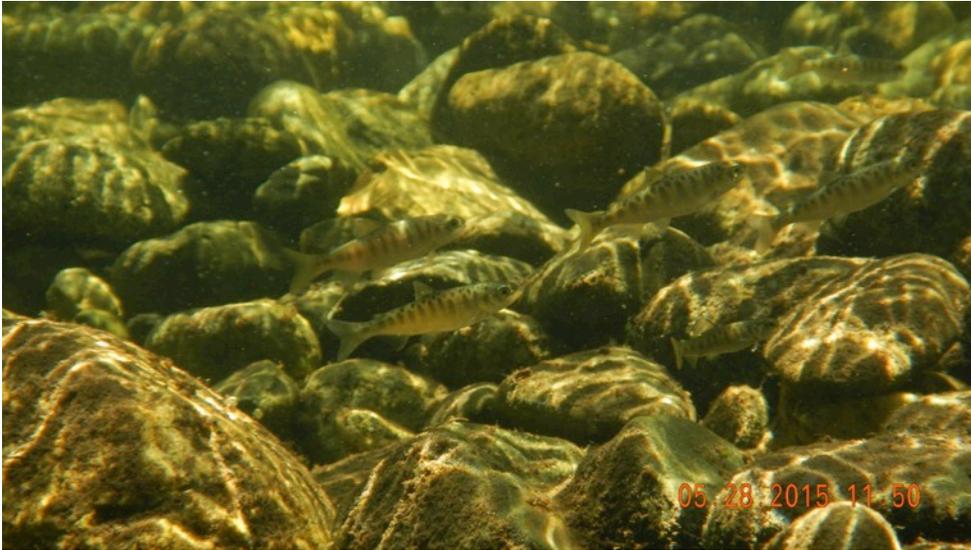
Figure 30. Juvenile coho and Chinook salmon on May 28th, 2015, showing the similarity in size (photo: L. Magranet).

Juvenile coho and Chinook were close in size and developmental stage (Figure 30). However, young-of-the-year trout had recently emerged from the gravel and were found to be less than 30 mm (Figure 31). A snake was observed emerging from woody debris along the bank of the upper PAWS impoundment and capturing an age 1+ trout. None of the fish observed were handled.

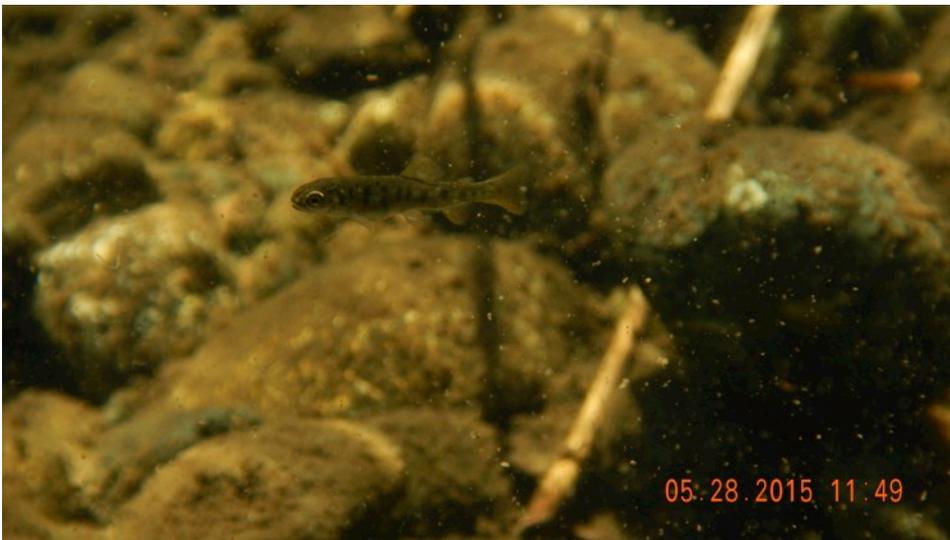
Figure 31. Steelhead/rainbow trout fry on May 28th, 2015 (photo: L. Magranet).

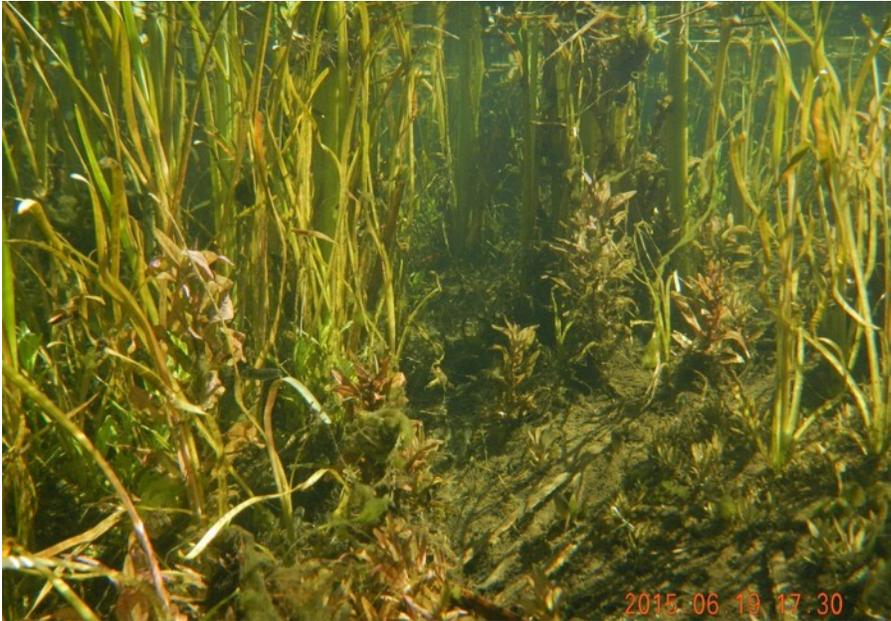
Figure 32. Emergent plants within the BDA impoundments that provide ample cover for rearing salmonids, June 19th, 2015. Compare with photo (below) of Sugar Creek below the BDAs (photo: L. Magranet).

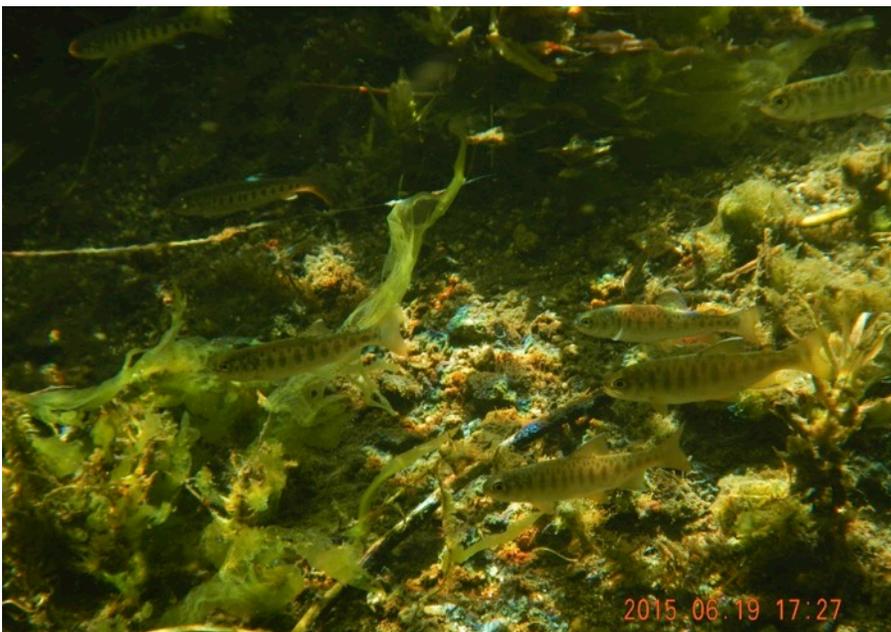
Figure 33. Coho and trout young of the year utilizing the lower BDA impoundment, June 19th, 2015 (photo: L. Magranet).

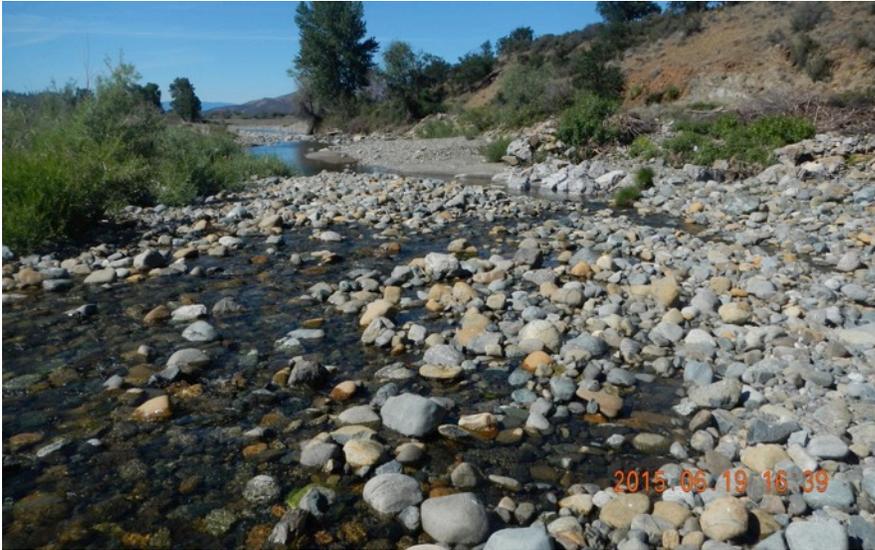
Figure 34. Sugar Creek in the foreground entering the Scott River on June 19th, 2015 (photo: L. Magranet). Note the lack of pools and generally simplified habitat structure. Compare with deep pools with complex habitat created by the BDAs (above).

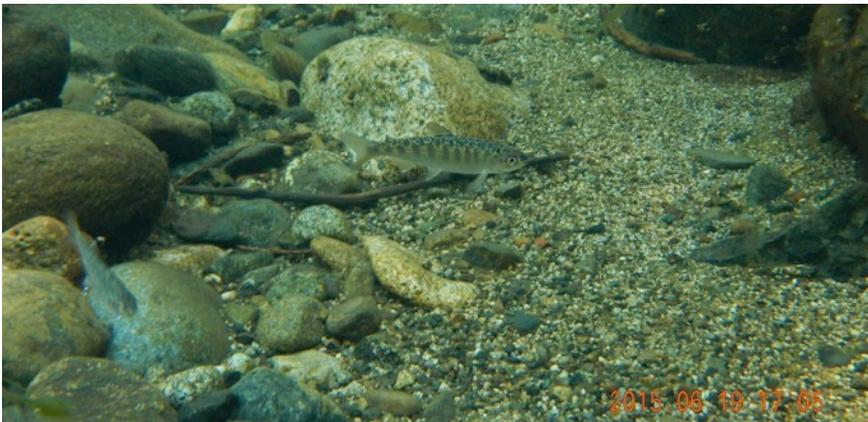
Figure 35. Chinook young-of-the-year encountered in Sugar Creek, in the limited habitat downstream of the project area, June 19th, 2015.
