Scott River Watershed Council

Winter 2014

CREATING COMMUNITY-BASED SOLUTIONS

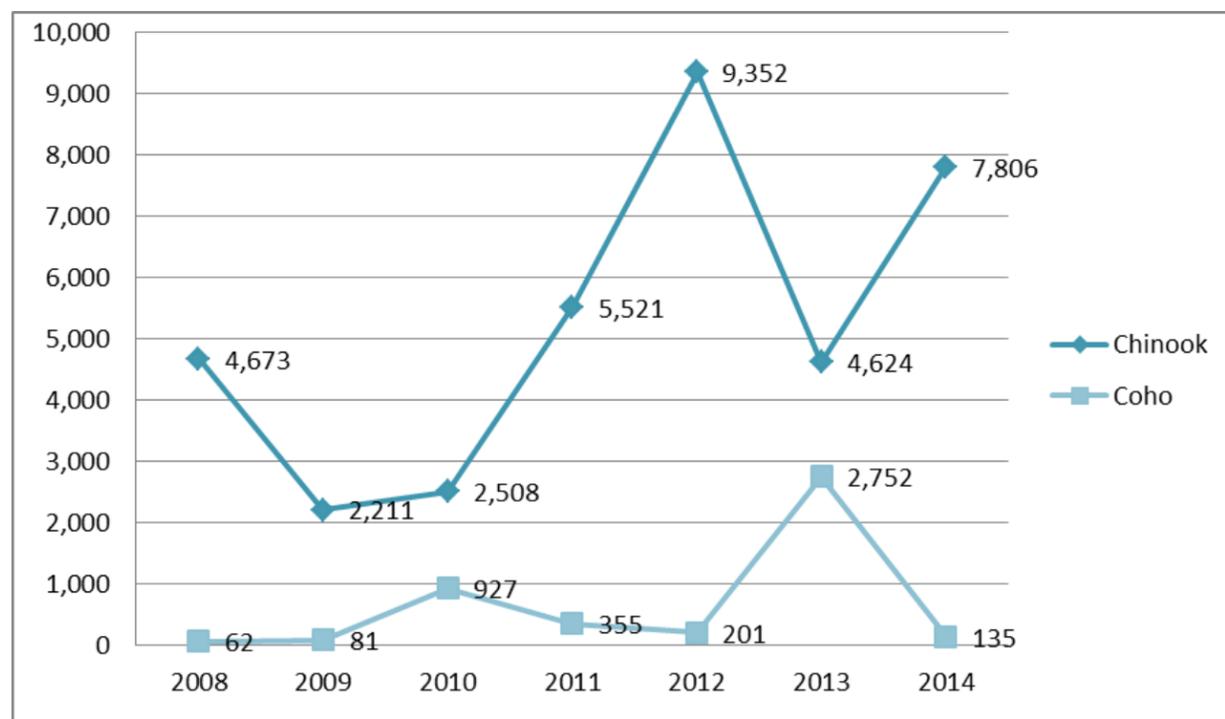
Table & Chart: Annual adult chinook and coho salmon population totals for the Scott River

2008	2009	2010	2011	2012	2013	2014
Chinook	4,673	2,211	2,508	5,521	9,352	4,624	7,806
Coho	62	81	927	355	201	2,752	135*

*The coho total for 2014 is incomplete, they are still moving up the river.

The table below illustrates the total amount of chinook and coho salmon that have entered the Scott River since 2008. The totals are calculated based on the number of salmon that pass through the CDFW Scott River Fish Counting station plus the Jolly-Seber mark recapture carcass-based estimates that are conducted in the areas downstream of the counting station. The counting station is located on the Scott River between Jones Beach and Indian Scottie Camp Ground. It is very encouraging that over the past three seasons a positive growth rate for Scott River coho salmon has been observed (Knechtle and Chesney, 2013 *Scott River Salmon Studies Final Report*).

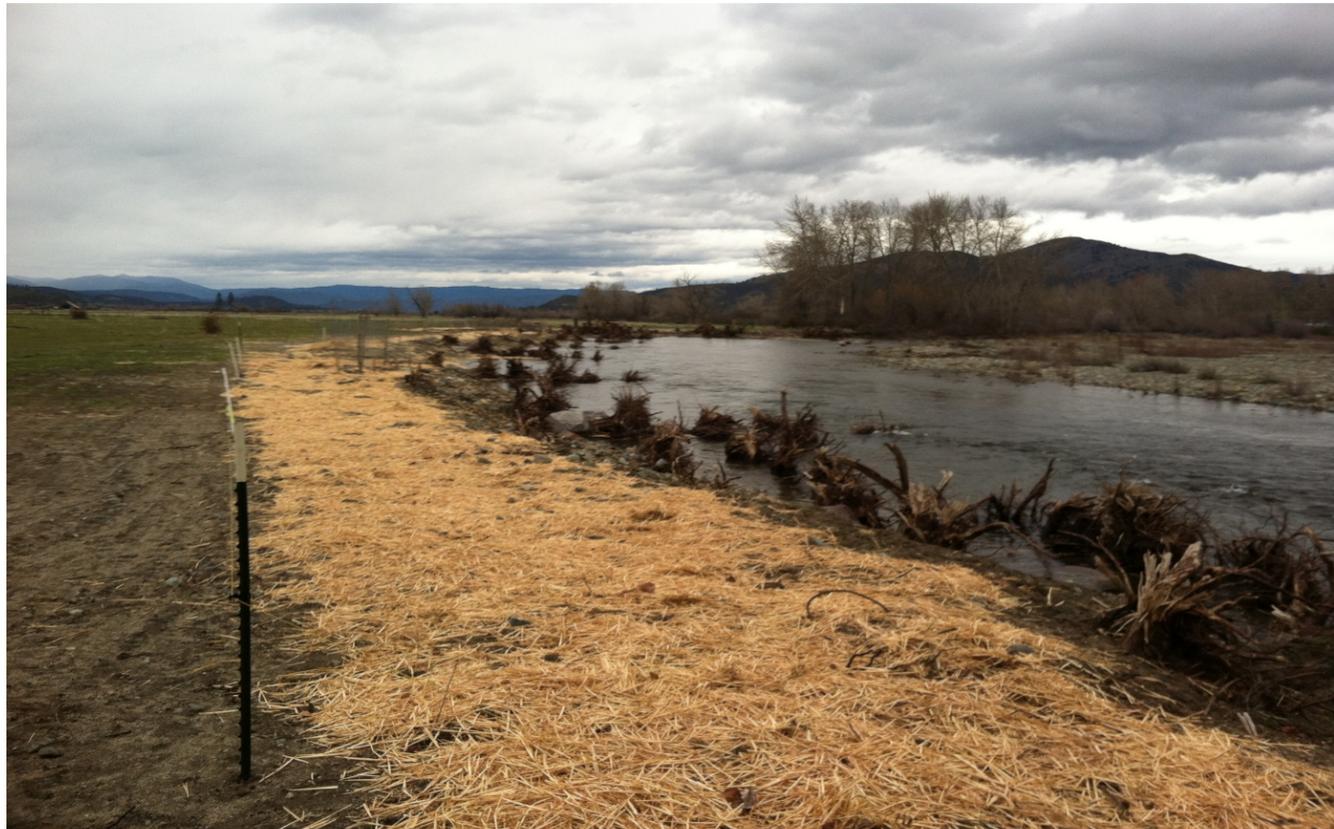
Photo 2: Southern end of RM 52 project site, December 2014 (Siskiyou RCD).

The objectives of this design are to reduce stream bank erosion by pushing the thalweg off the bank with the installation of anchored log barbs and engineered log jams. The project also addresses a secondary and highly erosive cusp, near the downstream end of the bank, with similar treatments. In addition, a complete revegetation of the 0.6-acre site was completed post construction to enhance the existing riparian corridor and establish trees to supply shade to the river. Thirty cottonwood pole cuttings were planted along the top of the left bank, an up to forty vertical willow bundles were buried between each of the instream log barbs. Photo points will be revisited annually when vegetation is fully leafed out (July) and counts will be made to evaluate survival.

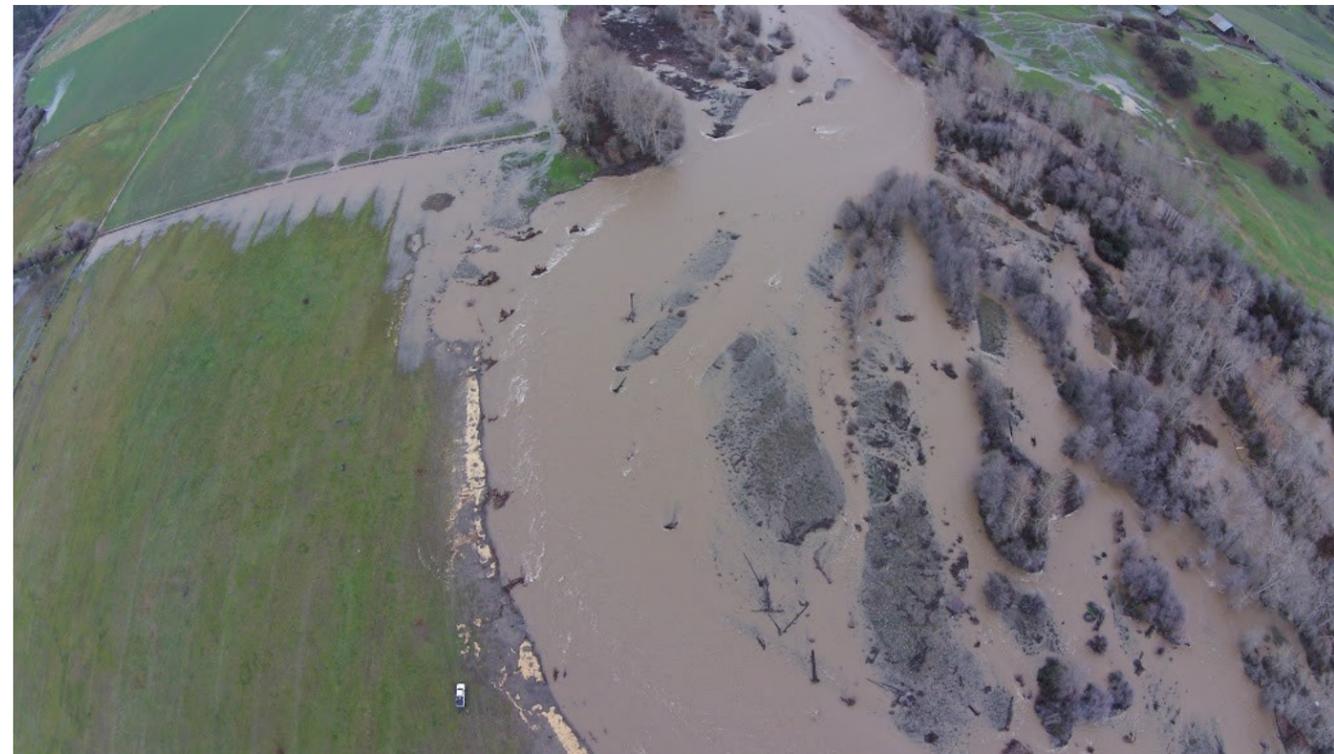
Photo 3: Shot during last week's flood

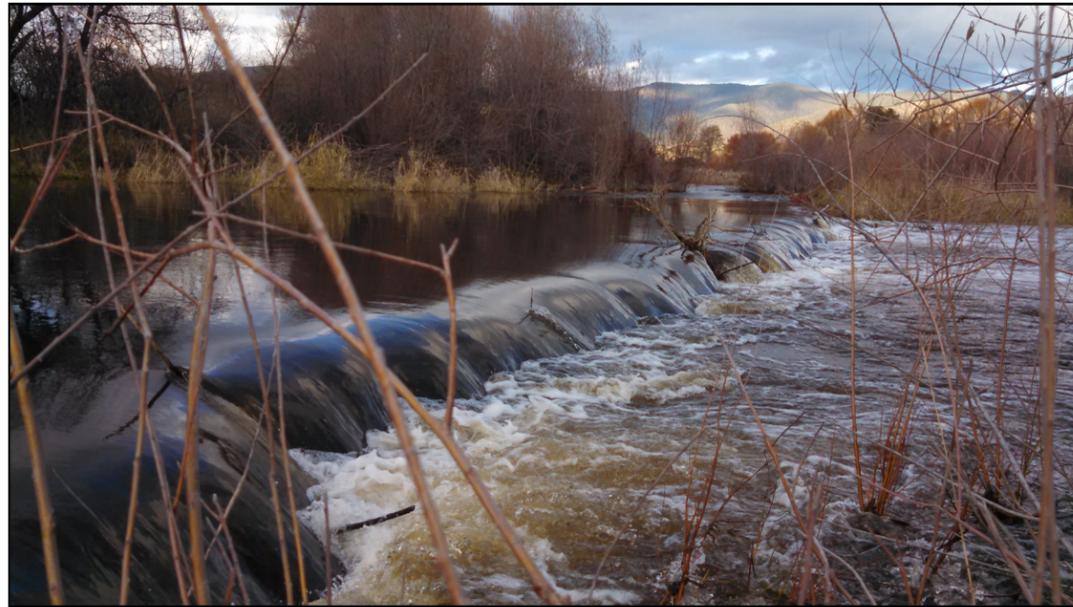
The willow weave is designed to trap leaves and debris during fall leaf off to form a seal that then traps sediment and creates complex, slow water habitat. This has happened accordingly and the structures have sealed off nicely. "It has been really exciting to see the large, extensive new slow water habitat that is being created by these structures" says Peter Thamer, the project coordinator and resident PAWS guru. "I am anticipating a large beneficial impact on the Scott's coho salmon population."

Thamer, is closely monitoring the structures throughout the winter for fish passage and how they respond and are impacted by high flow events. Observations to date suggest that both chinook and coho adults are well distributed throughout the watershed, both upstream and downstream of the structures. Thamer is working with scientist Michael Pollock of NOAA Fisheries, local rancher Betsy Stapleton, and CDFW scientists in Yreka, to create a fish monitoring protocol that will assess the benefits of PAWS on our watershed's coho salmon population. Thirty two monitoring wells were installed in order to evaluate the impact the PAWS have on groundwater. Water temperature and dissolved oxygen will also be monitored.

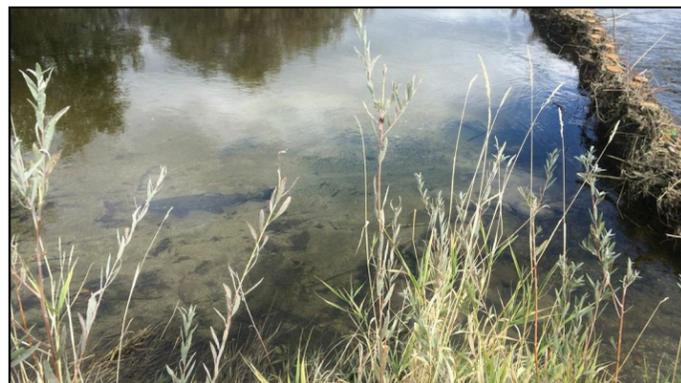
Salmon above a PAWS structure

PAWS near French Creek confluence

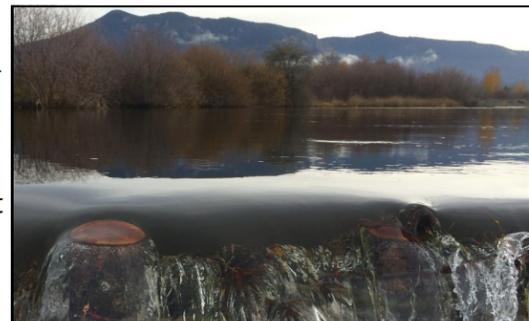
Pool created by PAWS

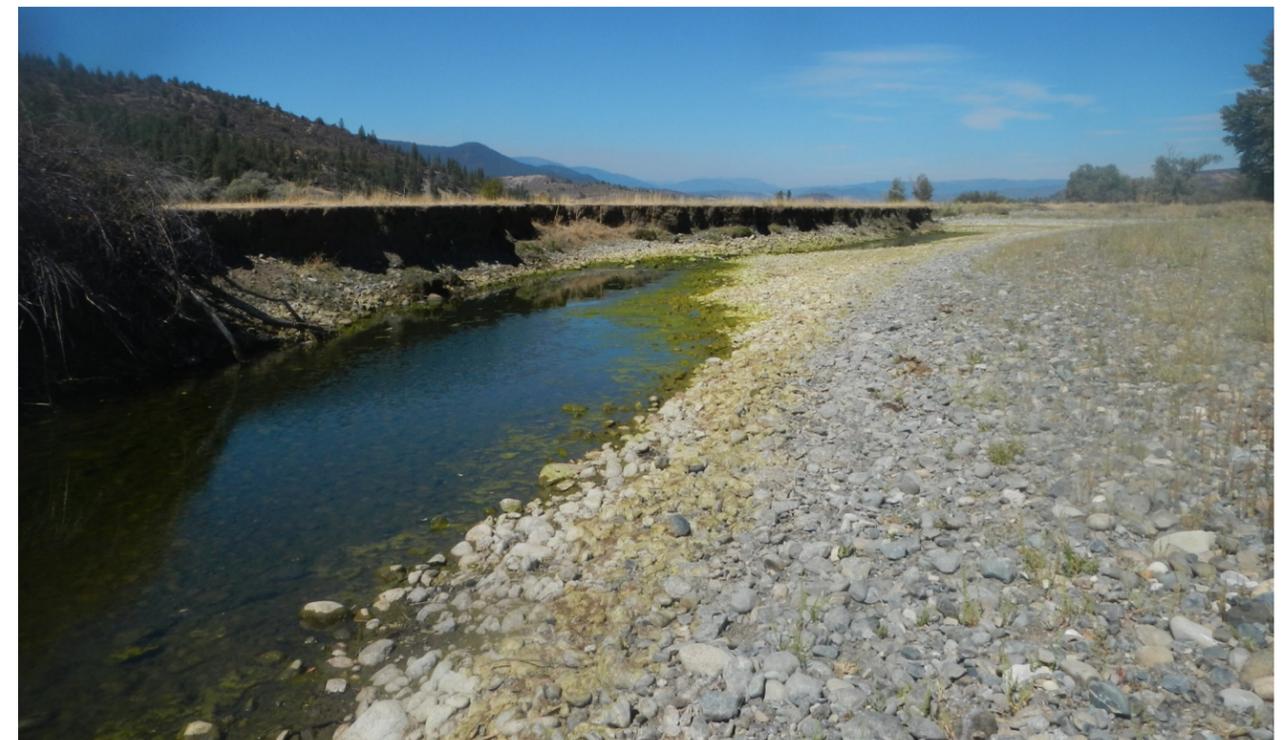
Photo 1: Bank to be treated, looking downstream, September 2014 (Siskiyou RCD)

This project took place on private property in the southern end of Scott Valley. The active channel width at this site is approximately 800 feet and composed of a gravel and sand streambed with areas of clay exposure. During high flows, the velocities near the bank are very swift and were actively eroding the sand lenses at the toe of the bank, which undermined the above clay layer and led to an estimated 469 tons of sediment contributions per year in a reach that is important to spawning and rearing Chinook salmon, coho salmon and steelhead trout. The continued erosion on the outside of this meander did not only impact adjacent agriculture fields, but it had the potential to flank the downstream riparian corridor and move the river into neighboring properties.
